DOT HS 808 220

June 1994

# **Final Report of a 1991 Chevrolet Silverado into a 50% Left Offset Barrier in Support of CRASH3 Damage Algorithm Reformulation**

The purpose of the five (5) 50% left frontal offset barrier impact tests was for research and development in support of the CRASH3 damage algorithm reformulation.

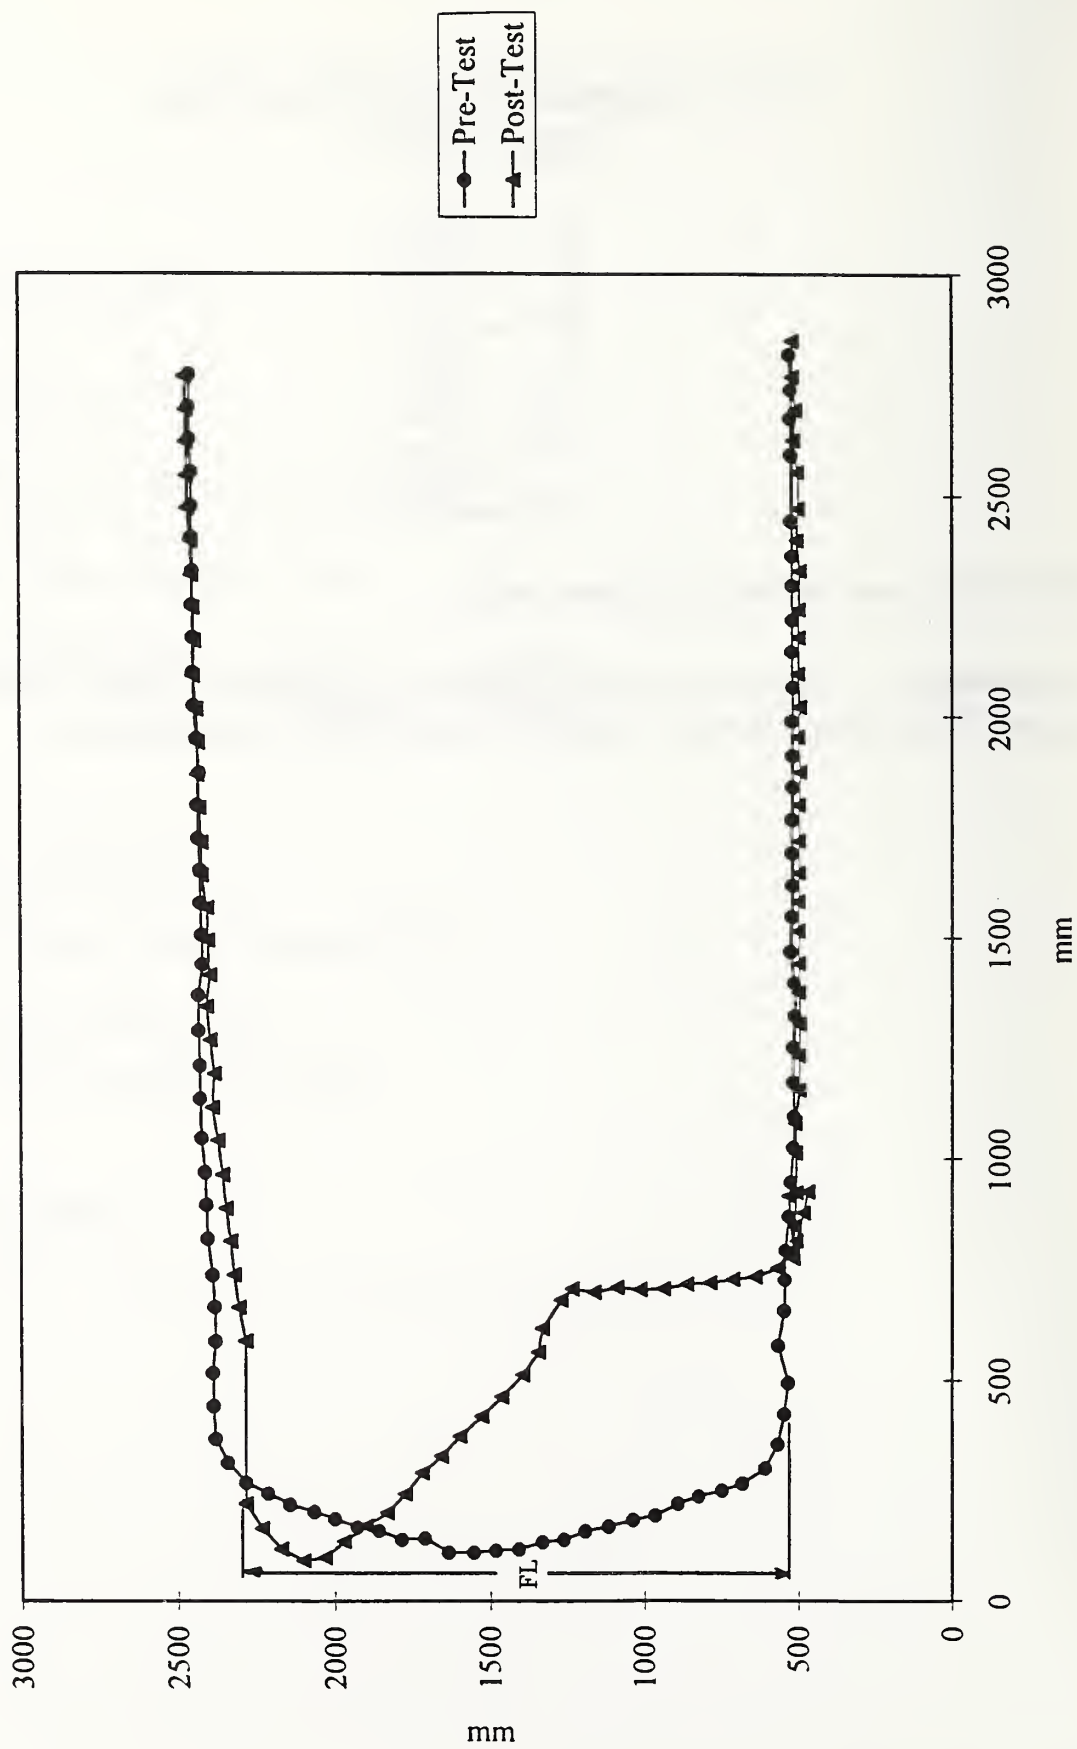
Figure 5 Vehicle Crush Profile At Bumper Height  
Test 940613-3

NOTE: FL is post-test length of damaged surface.

Measurements C1 - C6 were spaced equally apart over the post-impact length of the damaged surface. This distance is defined as length "FL" on the vehicle crush profile plot.

All measurements are in millimeters.

Length Of Direct Contact Damage: 885 mm

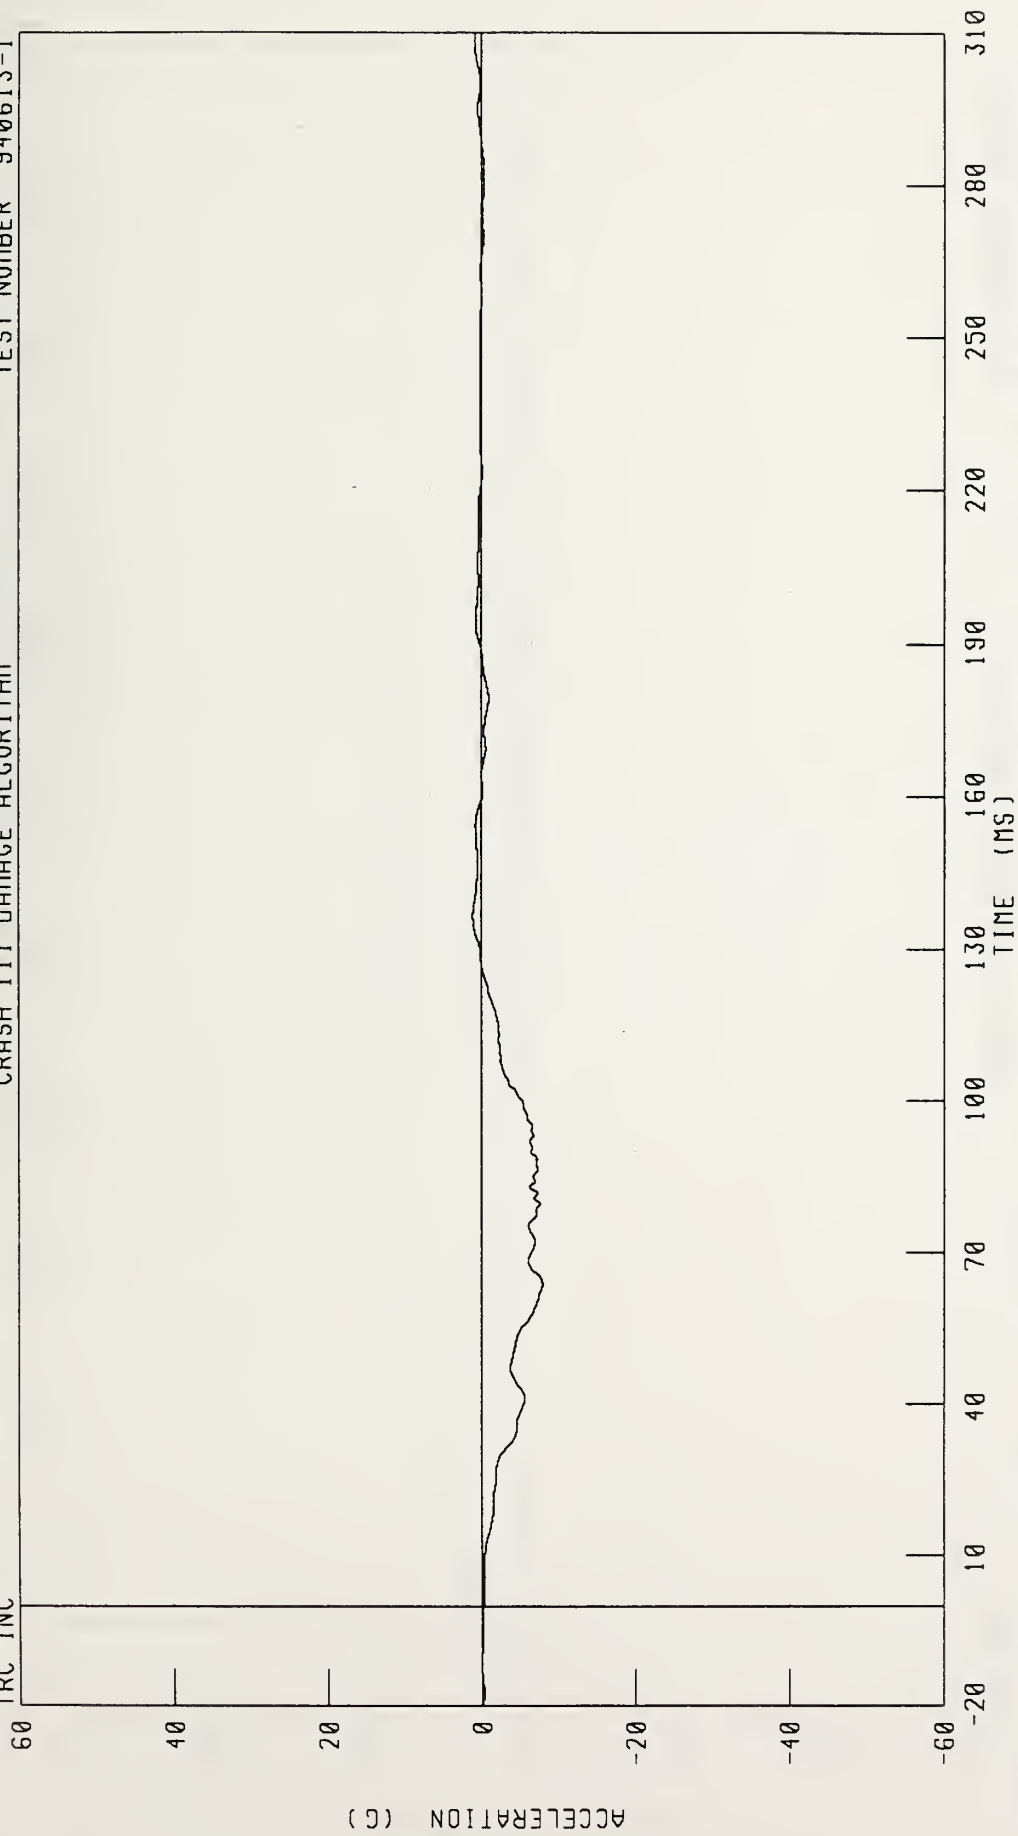
TEST NUMBER 940613-1

CHANNEL VCGXG1 FILTER CH CLASS 60

PEAK DATA 1 14 G @ 136 40 MS, -7 88 G @ 63 76 MS

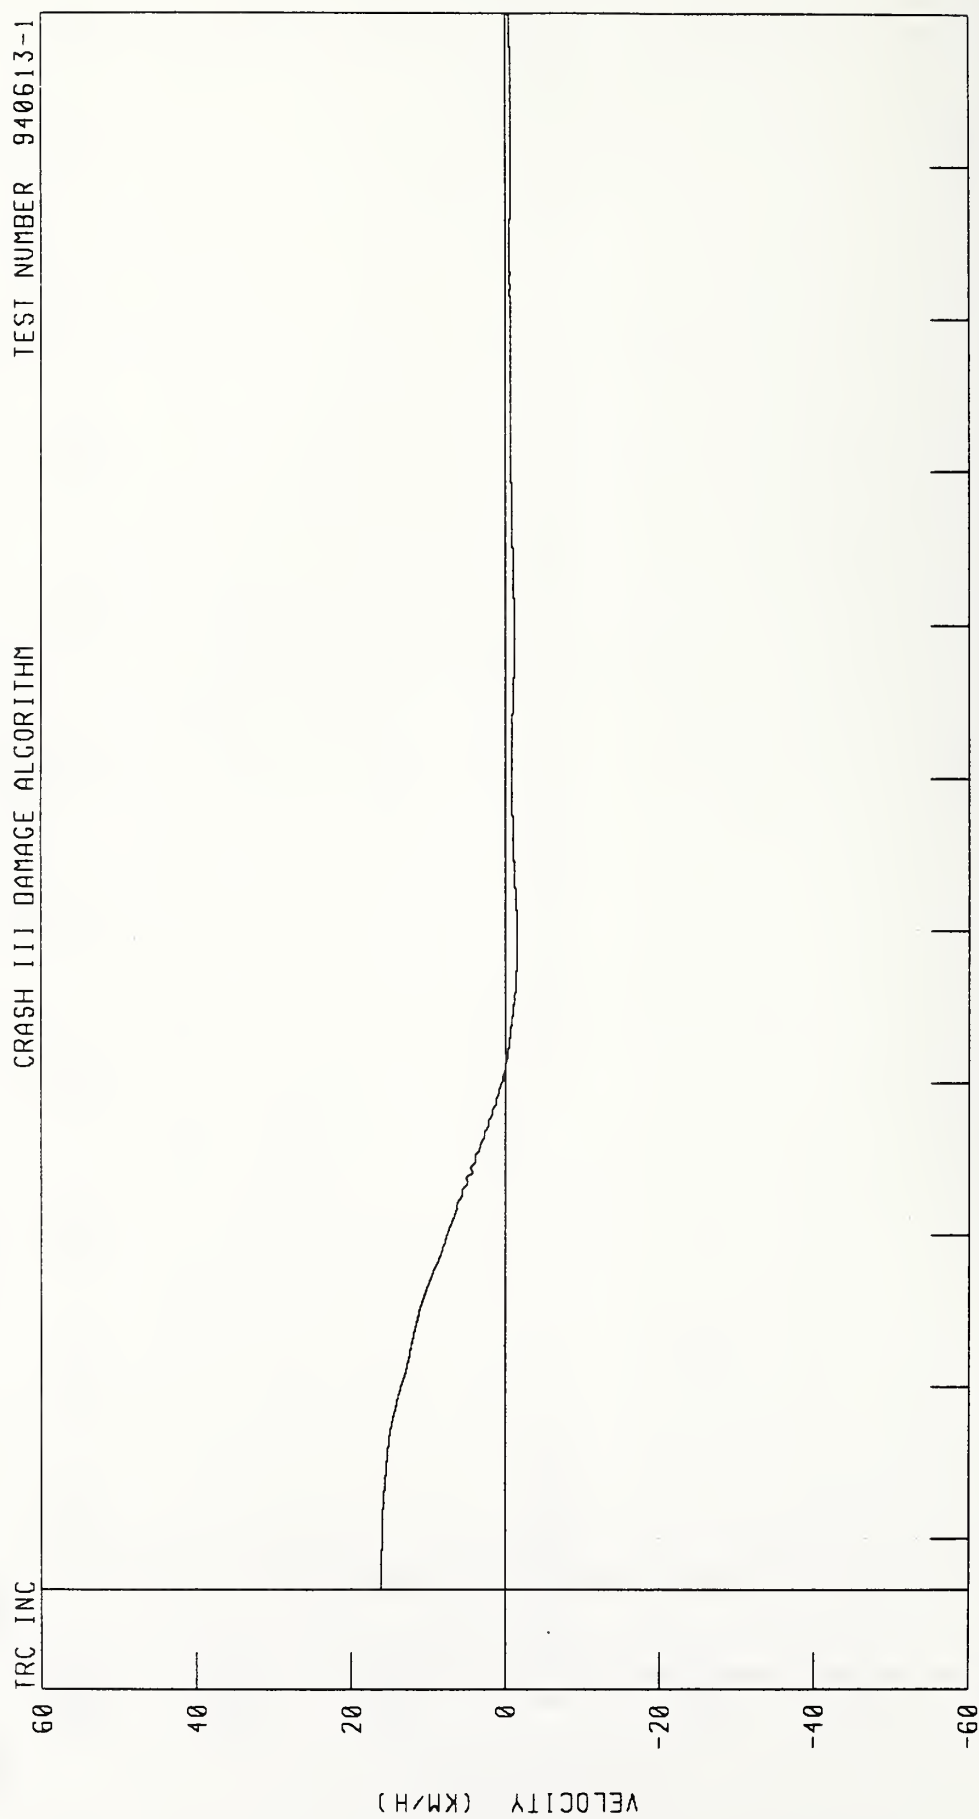
TEST NUMBER 940613-1

CHANNEL VCGXV1 FILTER CH CLASS 180 PEAK DATA 16.10 KM/H @ 0.00 MS, -1.52 KM/H @ 127.04 MS

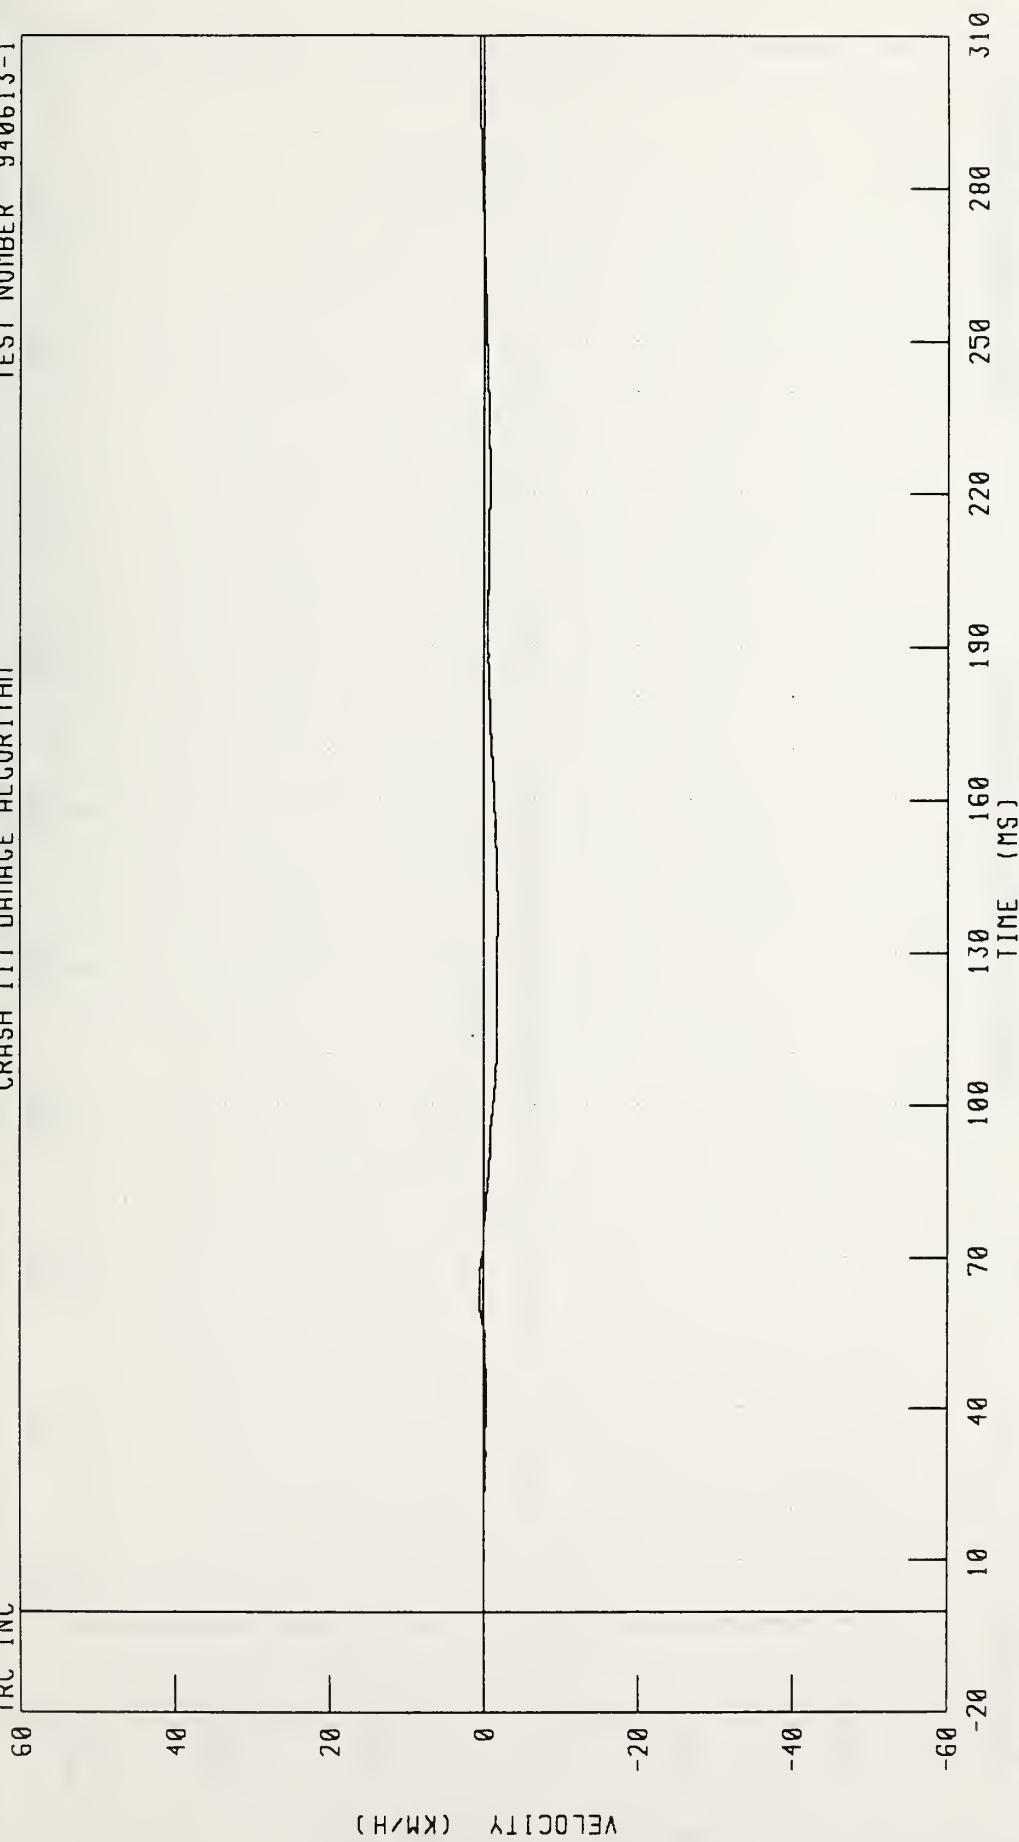
TEST NUMBER 940613-1

CHANNEL VCGYV1 FILTER: CH CLASS 180

PEAK DATA 0 57 KM/H @ 304 64 MS; -1 80 KM/H @ 137 12 MS

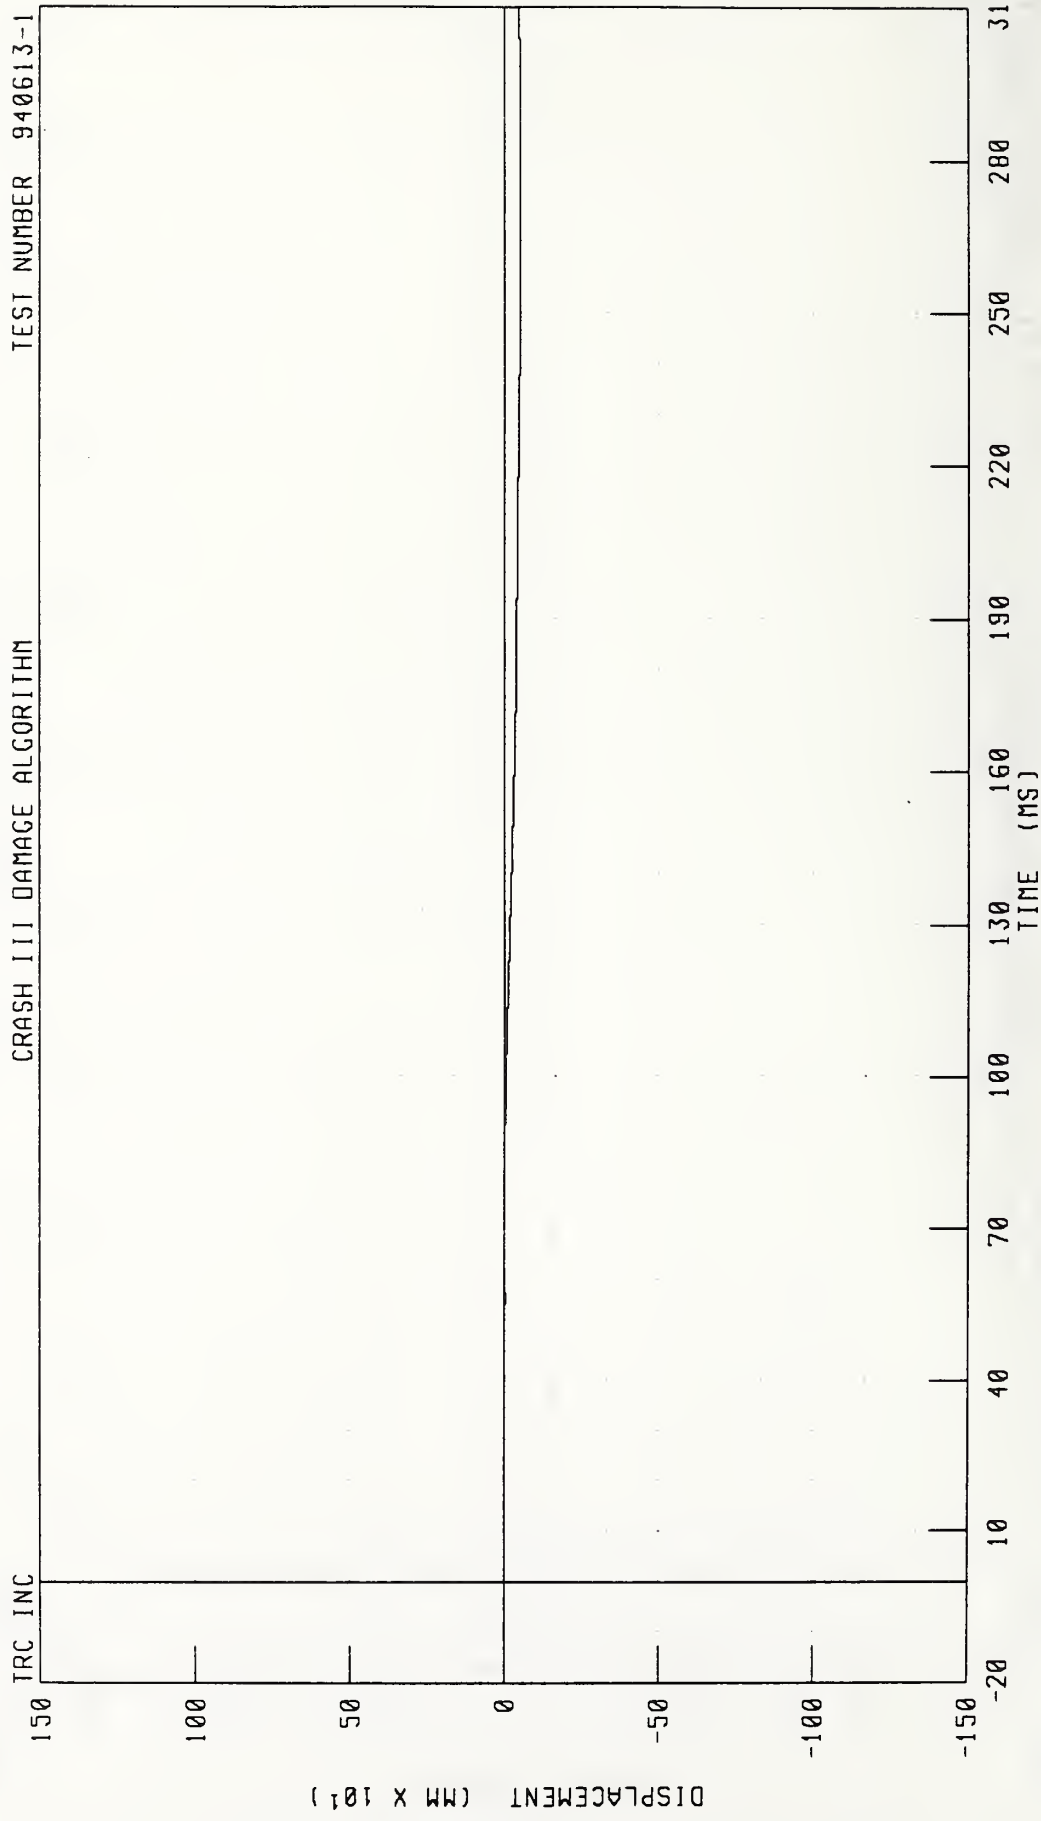
TEST NUMBER 940613-1

CHANNEL VCGYD1 FILTER CH CLASS 180

PEAK DATA: 0 24 MM @ 21.36 MS, -51 28 MM @ 268.96 MS

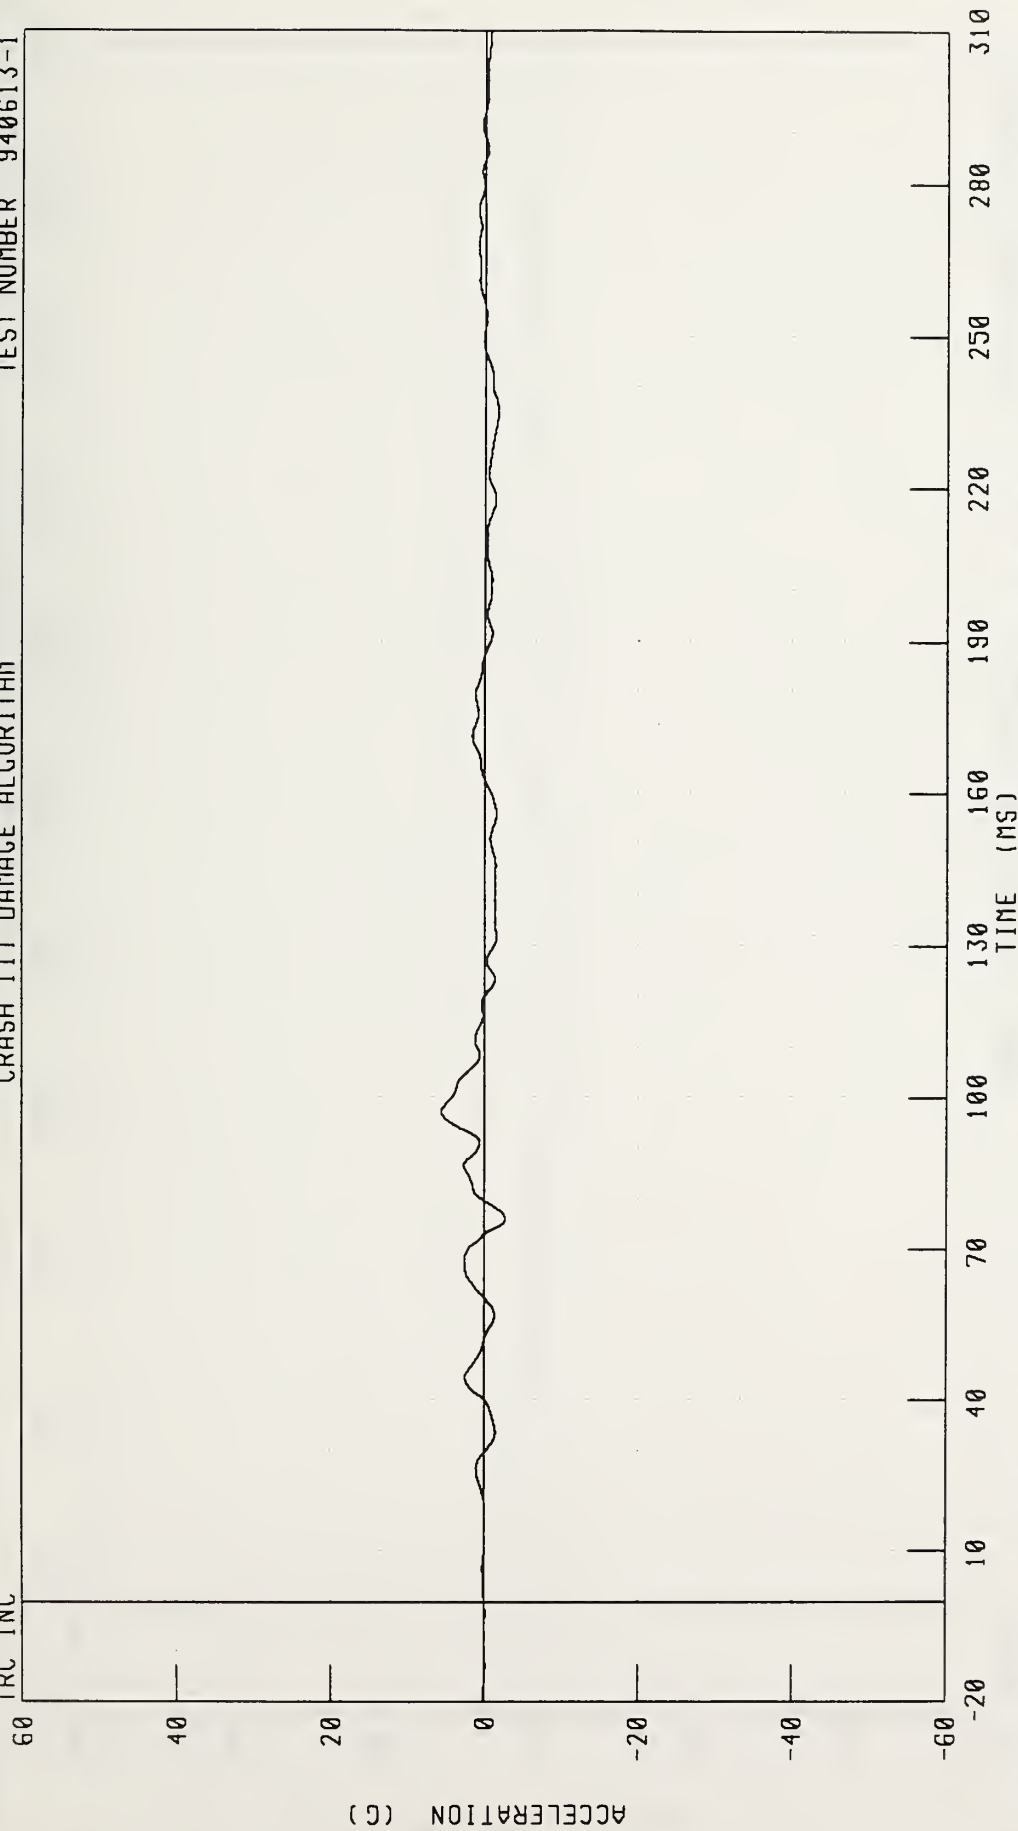
TEST NUMBER 940613-1

CHANNEL VCGZG1 FILTER: CH CLASS 60

PEAK DATA: 5 60 G @ 97.20 MS; -2 64 G @ 76 08 MS

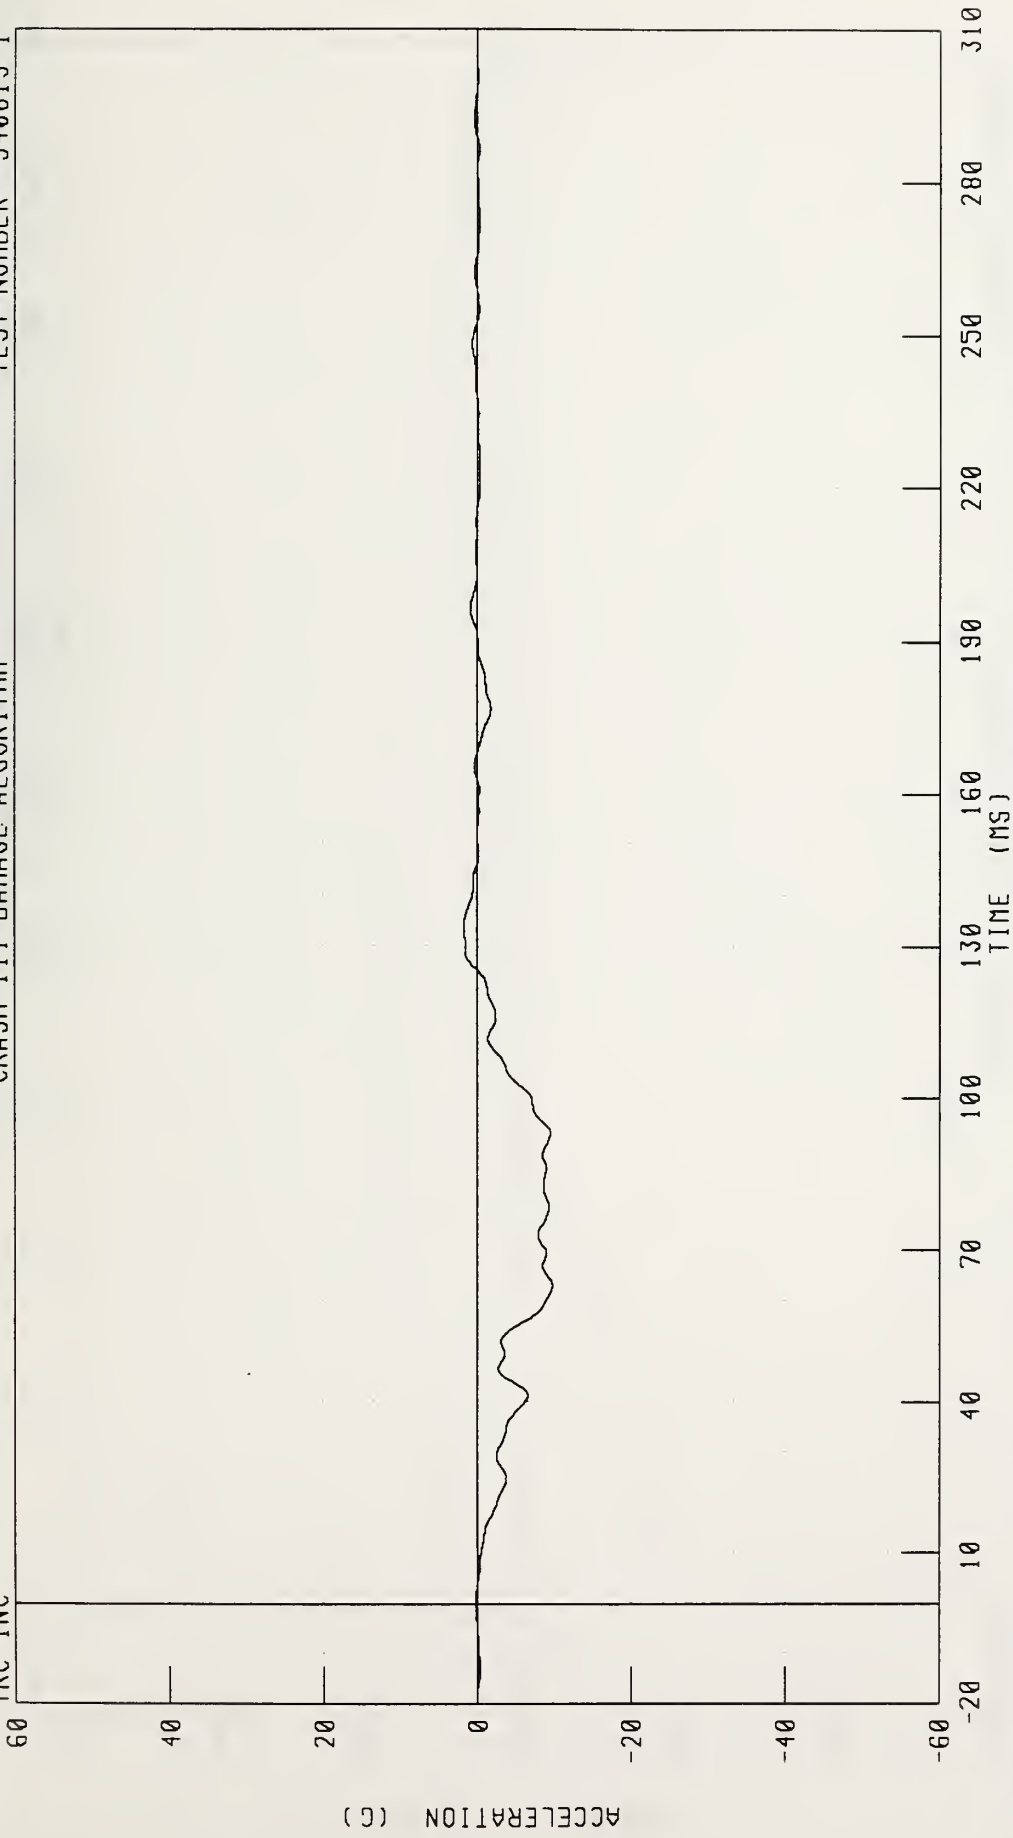
TEST NUMBER 940613-1

CHANNEL LRSXG1 FILTER CH CLASS 60

PEAK DATA 1 75 G @ 133 60 MS, -9 76 G @ 62 96 MS

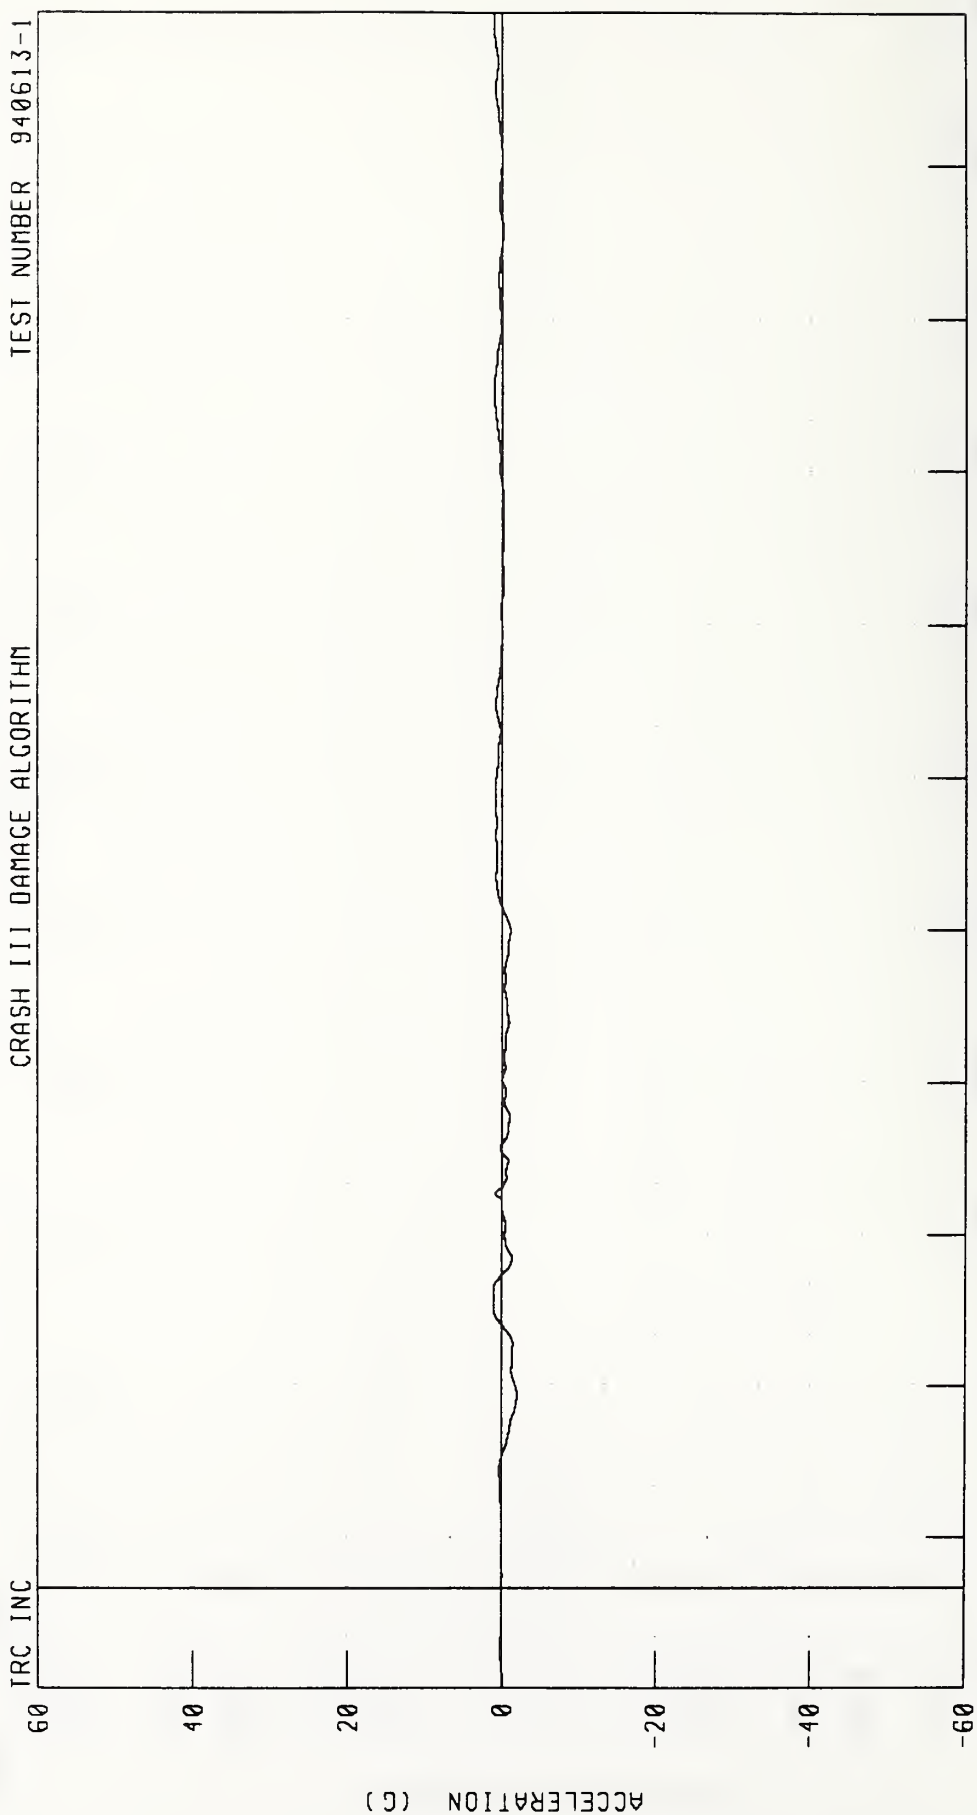
TEST NUMBER 940613-1

CHANNEL: LRSYG1 FILTER: CH CLASS 60

PEAK DATA: 1 09 G @ 58 88 MS, -1 99 G @ 38 16 MS

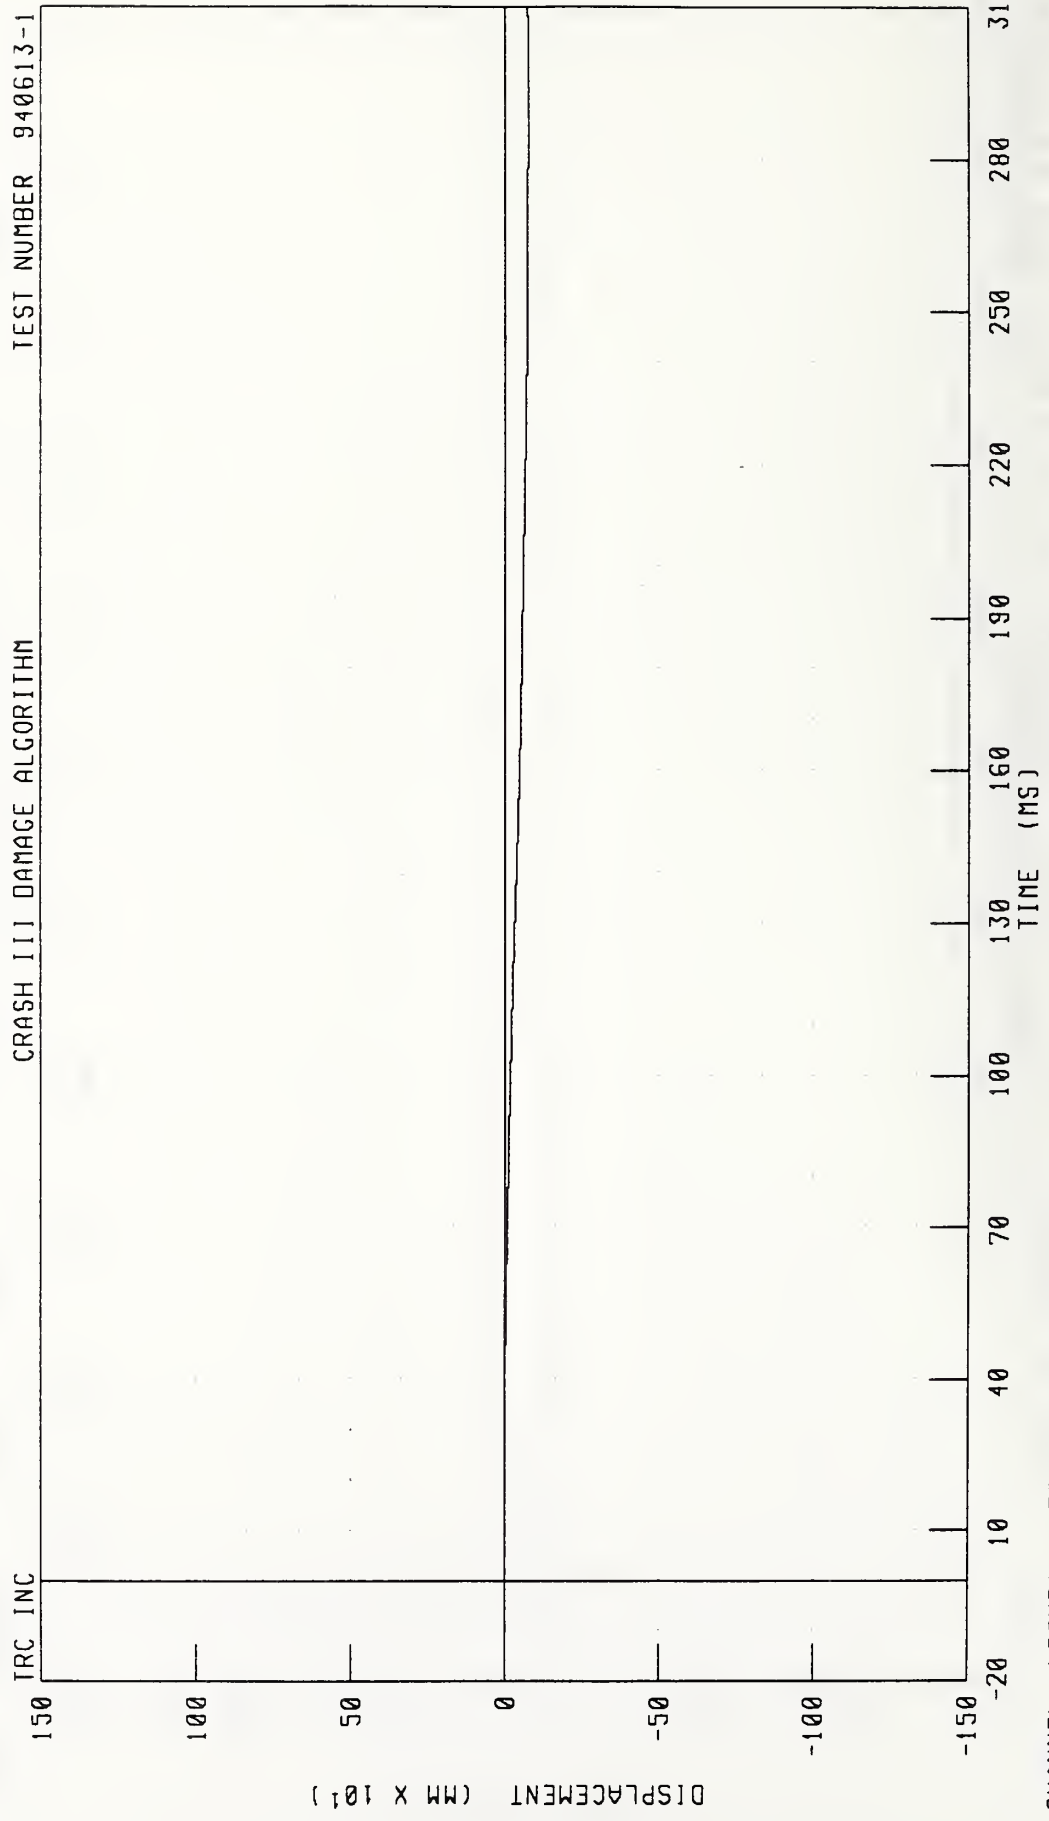
CRASH III DAMAGE ALGORITHM TEST NUMBER 940613-1

1991 CHEVROLET SILVERADO PICKUP TRUCK INTO 50% LEFT OFFSET BARRIER  
LEFT REAR SILL Y-AXIS DISPLACEMENT

CHANNEL LRSYD1 FILTER CH CLASS 180 PEAK DATA: 0 08 MM @ 30.32 MS, -74.38 MM @ 294.56 MS

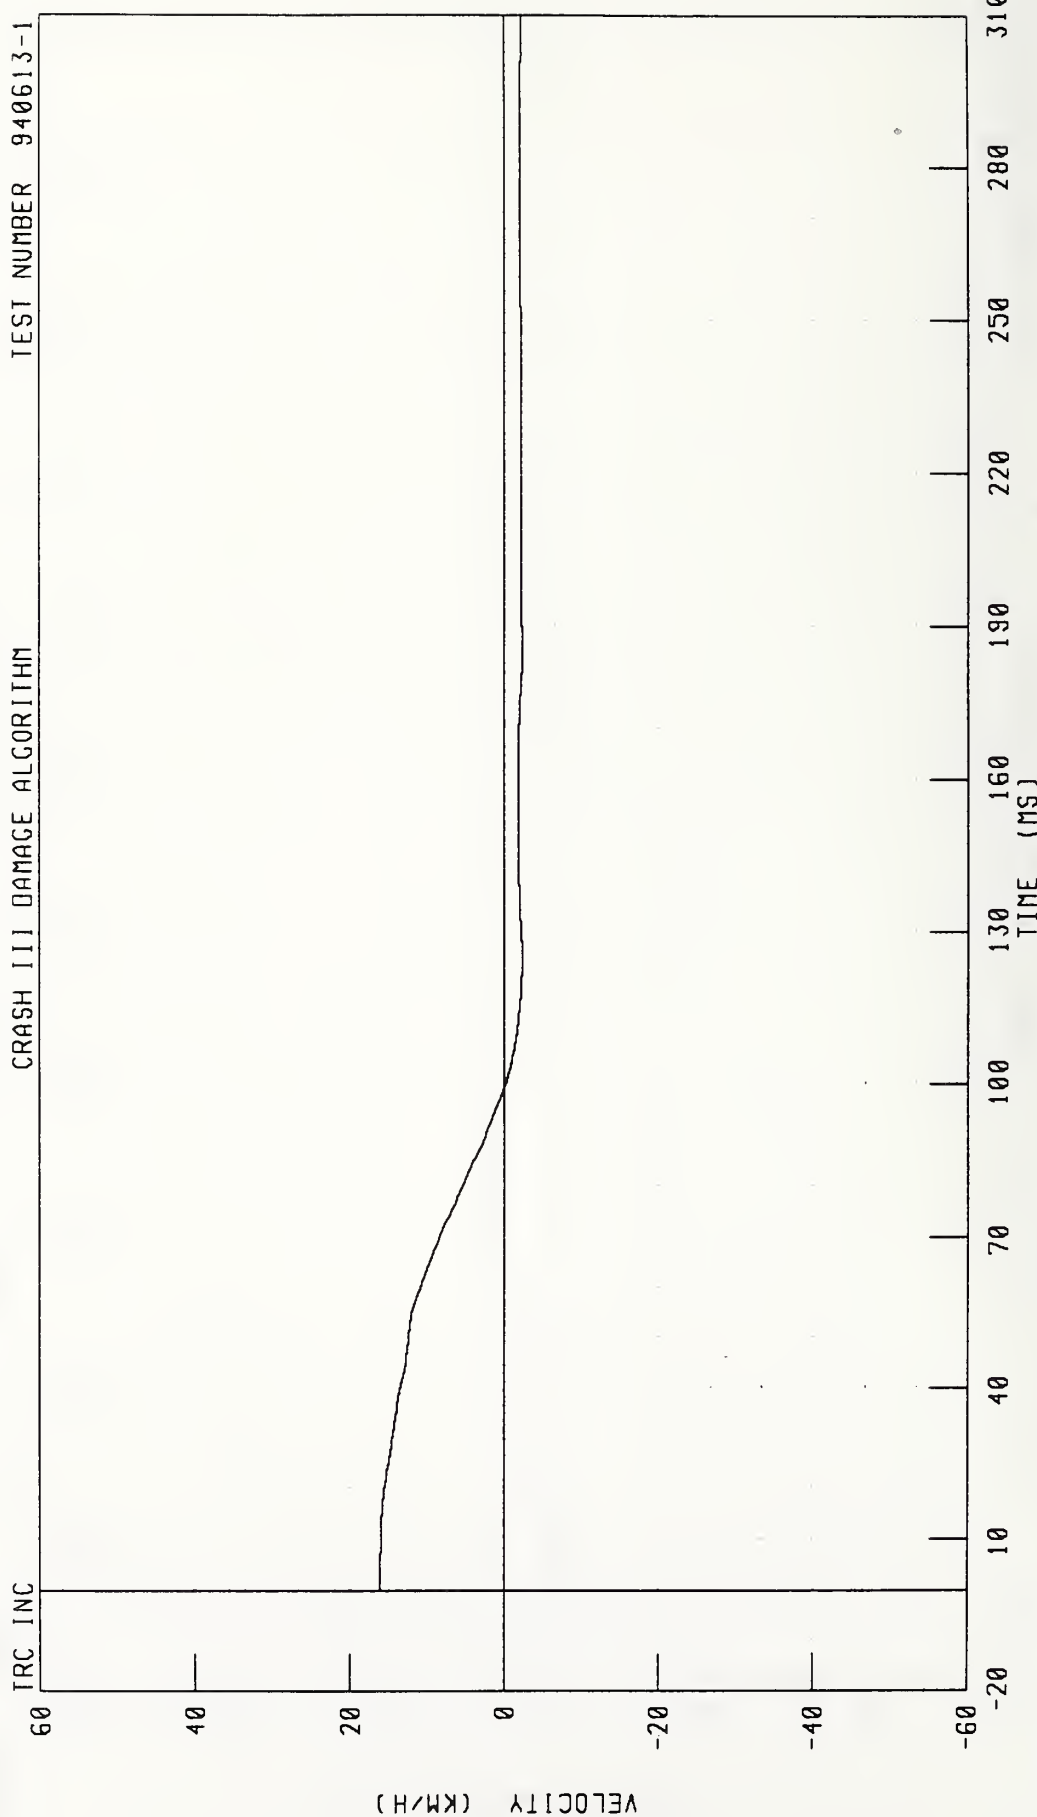
TEST NUMBER 940613-1

CHANNEL: RRSXV1 FILTER: CH CLASS 180

PEAK DATA: 16.10 KM/H @ 0.00 MS, -2.34 KM/H @ 183.44 MS

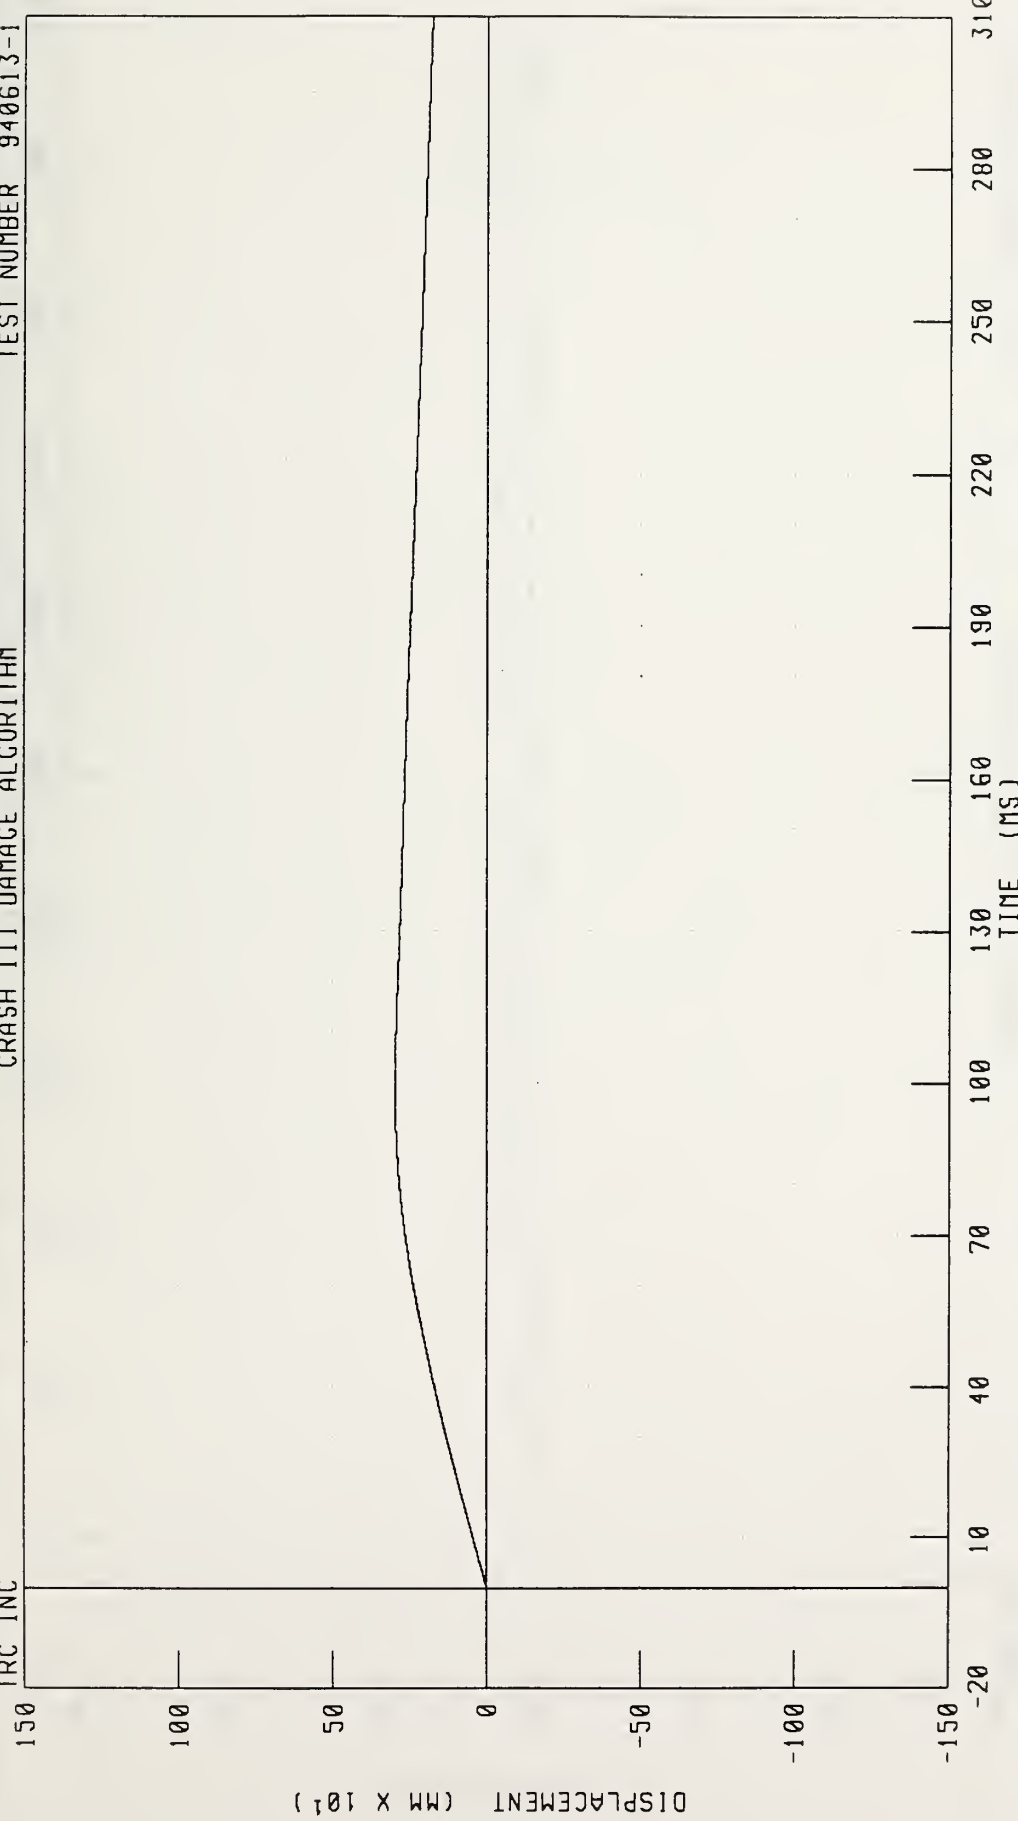
CRASH III DAMAGE ALGORITHM TEST NUMBER 940613-1

CHANNEL RRSXD1 FILTER CH CLASS 180

PEAK DATA 297 19 MM @ 99 28 MS, 0 00 MM @ 0 00 MS

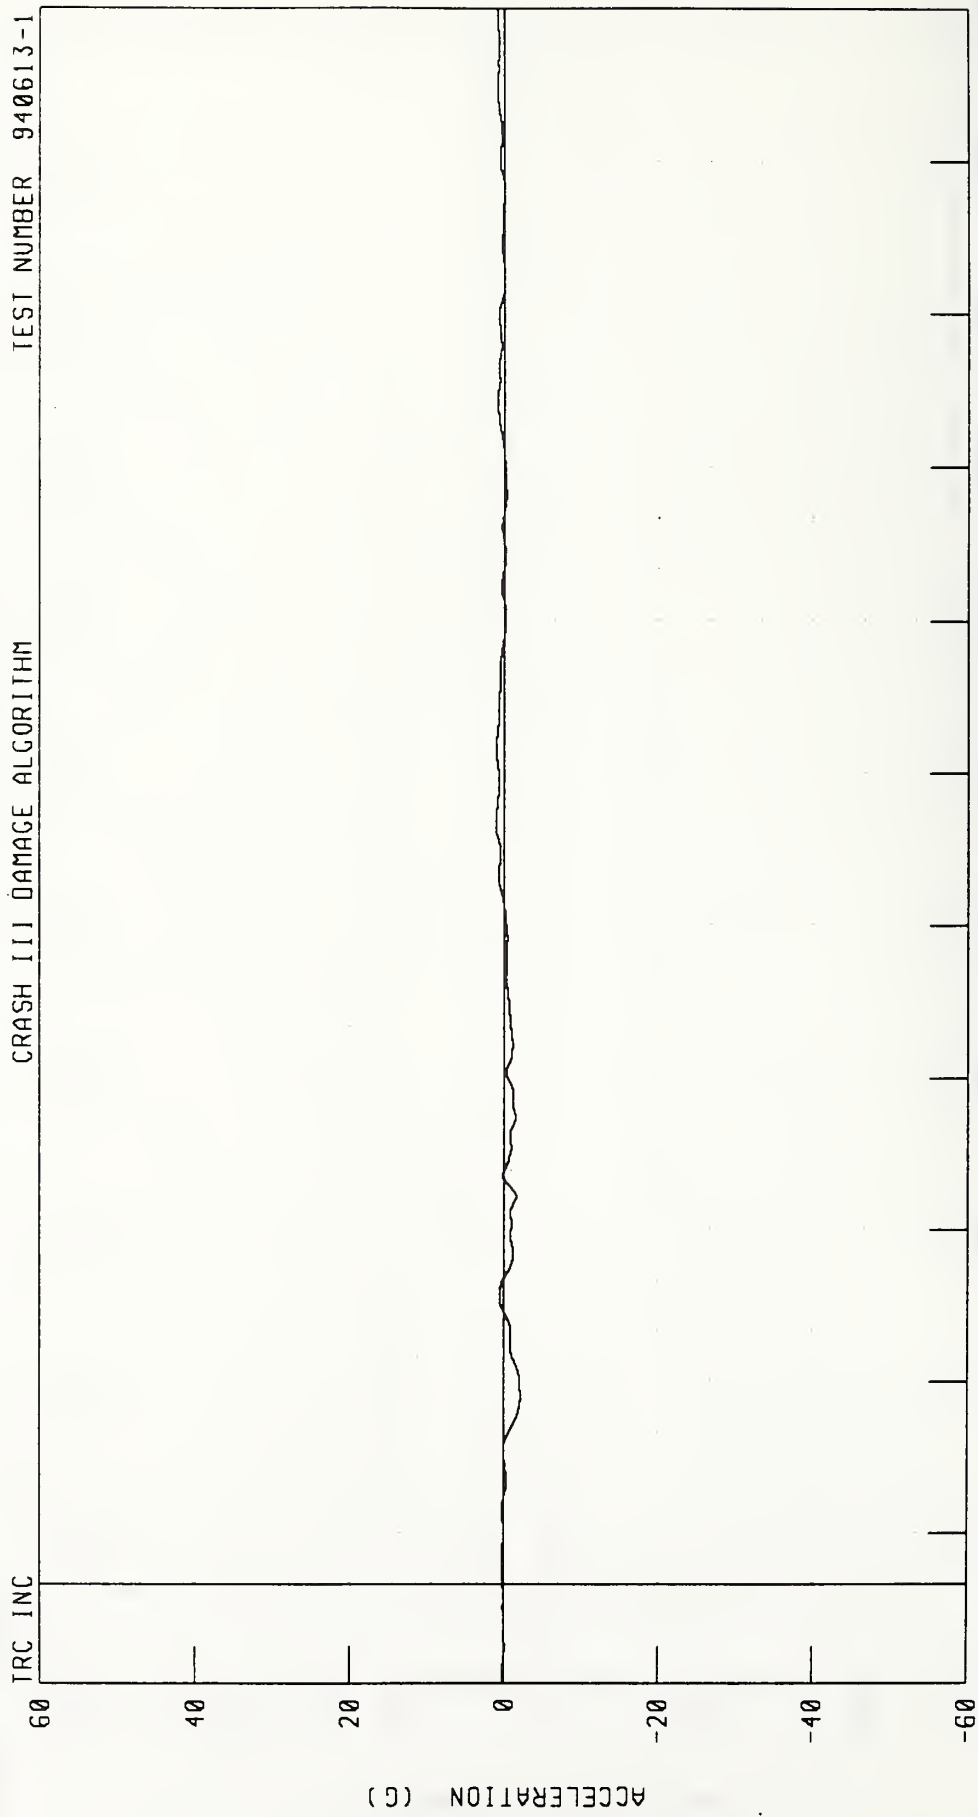
TEST NUMBER 940613-1

CHANNEL RRSYG1 FILTER CH CLASS 60

PEAK DATA: 1 10 G @ 150 48 MS, -2.17 G @ 37 12 MS
